# **General Aviation Airworthiness Alerts**

**AC No. 43-16**

**ALERT NO. 237  
APRIL 1998**

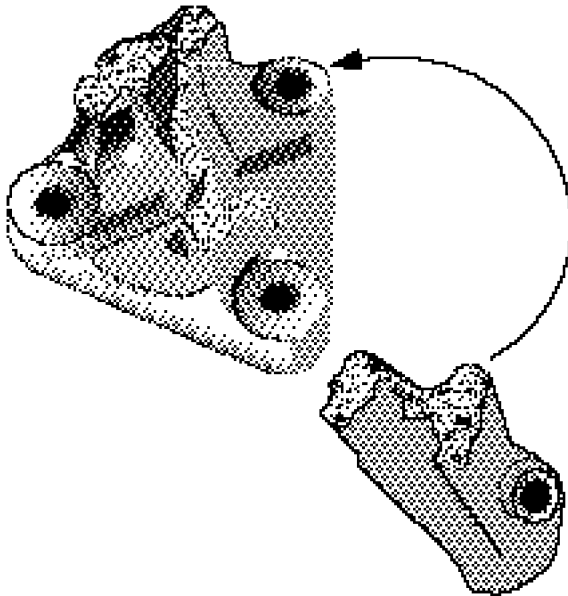
**Beech; Model M-35; Bonanza; Broken Engine Mount Brackets; ATA 7120**

During an annual inspection, both engine mount brackets on the left side were found broken. (Refer to the following illustration.)

The broken brackets allowed the engine to sag to the left which caused further damage to the valve covers, cowlings, and intake manifold. The engine mounts were checked 30 hours earlier during an engine oil change and were found to be serviceable. Since that check, the pilot did not notice any anomalies. The submitter suggests that special attention be given to the engine mount brackets (P/N TCM 626089) during scheduled inspections and maintenance. Any suspect brackets should be inspected further by using an appropriate nondestructive inspection technique.

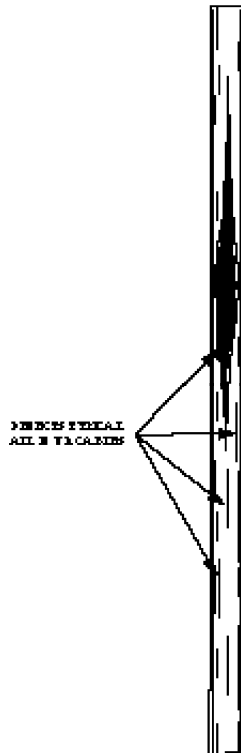
**Beech; Model C-90; King Air; Defective Electrical Wiring; ATA 2435**

During a scheduled inspection, four defective electrical cables were discovered.

The submitter discovered deteriorated insulation shielding on the electrical cables that come from the left engine starter/generator (cable or wire P/N MS22759-8 and individual cables P/N's P10C4, P10A4, K2D4, and K2F4). The shielding had split lengthwise to the cables, and the center conductor was exposed at several locations. (Refer to the following illustration.) These cables carry high amperage. If the cables had shorted to ground, the resulting arc could easily have severed critical structural components of the aircraft as well as contributing to the danger of fire and explosion. These electrical cables should be inspected at every opportunity.

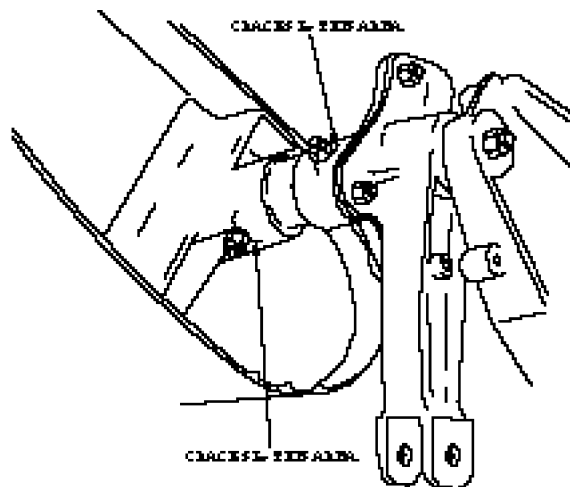
**Beech; Model C-99; Airliner; Elevator Torque Tube Cracks; ATA 5520**

Beech Service Bulletin (SB) 2145 requires disassembly and inspection of the elevator torque tube assembly (P/N 115-610015-3) at 1,000-hour intervals. The area of concern, as stated by the submitter, is cracks adjacent to the two taper pin fasteners used on the torque tube assembly. (Refer to the following illustration.) The cracks appear to originate at the nut side of the fasteners and degraded the structural integrity of the assembly. The submitting operator has adjusted the inspection interval for the elevator torque tube assembly to every 100 hours of operation after the first 1,000-hour inspection that is required by SB 2145. The submitter stated that cracks seem to occur between 1,400 and 1,700 hours of operation. The submitter stated this defect may be caused by high frequency vibration.

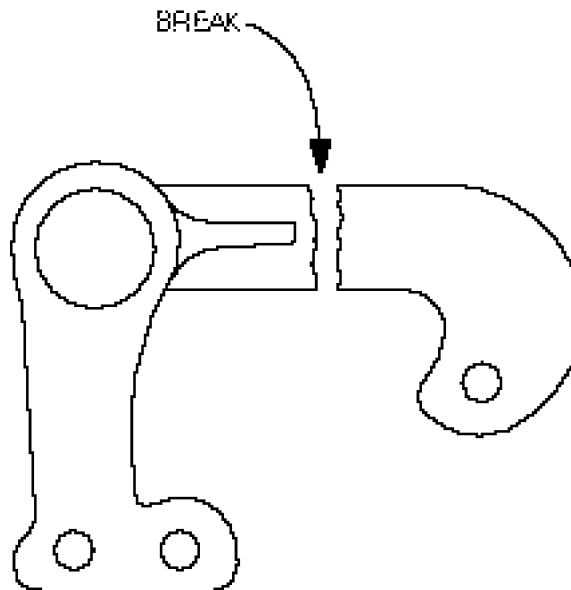
**Cessna; Model 421B; Golden Eagle; Landing Gear Door Linkage Failure; ATA 3231**

After a flight, it was discovered that the right main landing gear door linkage was broken.

The upper arm of the door bellcrank (P/N 0841106-6) was fractured. (Refer to the following illustration.) The submitter stated it appeared this failure was the result of a pre-existing crack. The submitter stated that the crack may have been caused by metal fatigue. This area should be thoroughly inspected.

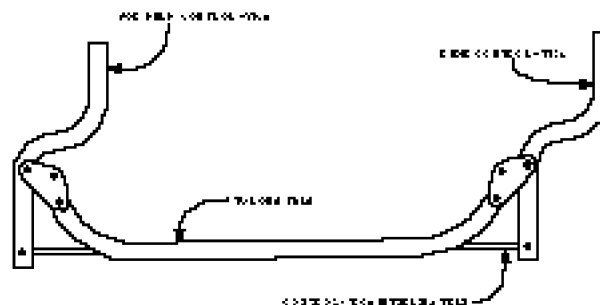
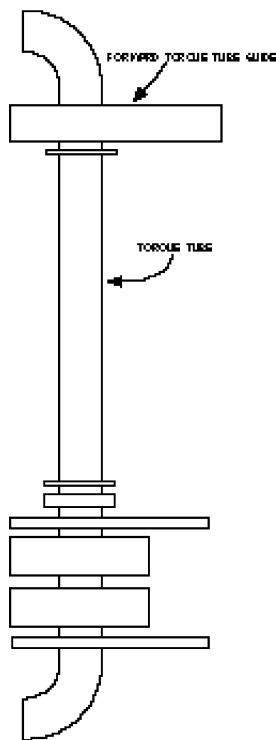
### Sportflight Aviation; Model Talon XP; Flight Control System Failure; ATA 2700

During flight, the flight control system torque tube failed and caused the complete loss of aileron and elevator control. The pilot activated the "Ballistic" recovery parachute, and the parachute functioned properly and saved life and property.

The forward end of the torque tube and the flight control stick separated due to "torsional loads." The aircraft kit assembly instructions did not caution the builder to install both fore-and-aft control sticks to the torque tube and interlink tube. (Refer to the two following illustrations.) The same flight control configuration is used on three kit models (Talon Magnum, Talon Super Magnum, and Talon XP) offered by this manufacturer. Since this occurrence, the manufacturer has issued a modification kit which replaces the torque tube with a thicker wall tube, reduces the cutout slot size at the torque tube radii outer bends, and provides for a doubler in the radii area for extra strength.

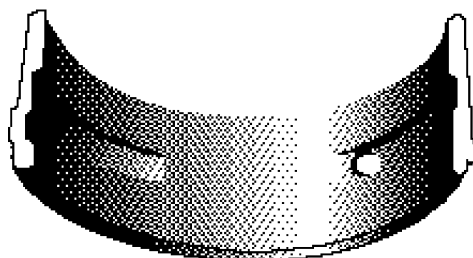
A closer examination revealed that the bearing (TCM P/N 634503-M010) had only one oil hole. (Refer to the following illustration.) These bearings are supposed to have two oil holes, one for oil supply to the crankshaft and one for oil supply to the piston cooling nozzle. Within one week, the submitter discovered two main bearings with this defect. The defective main bearings were found in bearing sets which had been shipped directly from the manufacturer.

The bearings are identified as coming from lot number "10-97." The manufacturer's supplier, who fabricated the bearings, supplied 1,174 bearings identified as lot number "10-97." Of that number, 682 have been located and inspected. There are still 492 bearings unaccounted for. All entities are urged to check their stock for any bearings part number 634503-M010, lot number "10-97," which were designed for the GTSIO-520 engine. If any of the subject bearings are found, please notify your Teledyne Continental representative as soon as possible so that this search may be completed promptly.
